# Sample HOME INSPECTION REPORT

**123 Smart St.  
Anywhere SC 29600**

**Inspection Date:**  
January 1, 2010

**Inspector:**  
Stephen Barker  
CMI,PHI,CHI  
Lic # 1982

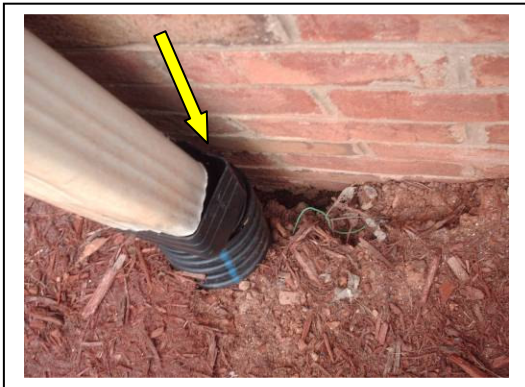
Loose downspout

- **Improve:** Loose or damaged downspouts at the rear slope by the garage should be repaired promptly.

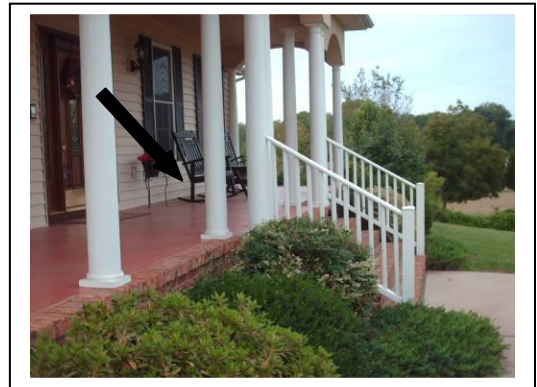
No porch rails at the front porch

- **Safety Issue:** As there is a danger of falling, a railing should be provided for the porch.
- **Monitor:** The patio has settled relative to the house proper. This is a common condition that should be monitored.

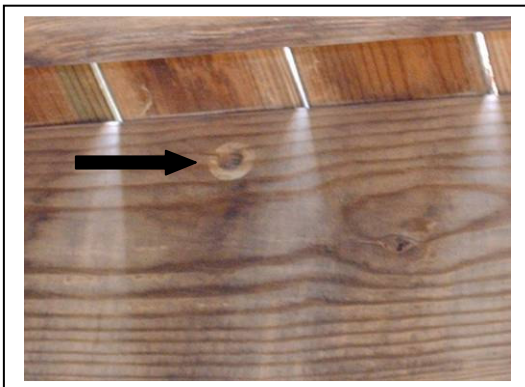
Lag bolts have been removed from the deck

- **Safety Issue:** The deck railing is loose. It is recommended that this be repaired for improved safety.
- **Improve:** The lag bolts along the east end of the deck have been removed.
- **Improve:** The broken deck board should be replaced.

- **Safety Issue:** The deck railing is loose. It is recommended that this be repaired for improved safety.
- **Improve:** The lag bolts along the east end of the deck have been removed.
- **Improve:** The broken deck board should be replaced.
- **Monitor:** Some minor flaws were observed in the decks construction. While improvement would be ideal, it is not considered high priority.

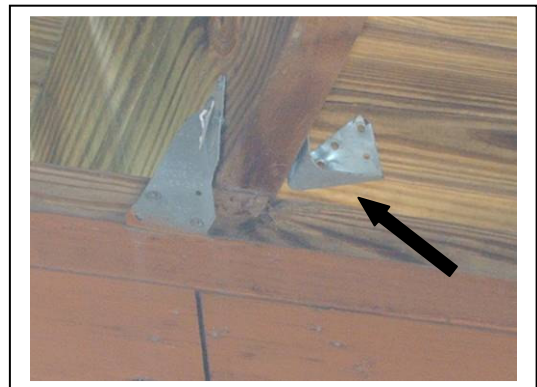
Minor framing defects at the deck

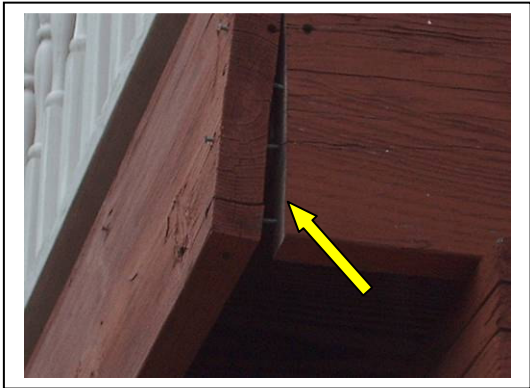
Loose boards a the deck

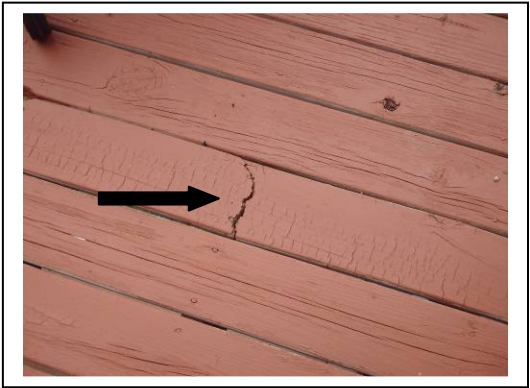
Damaged/broken walk board at the deck

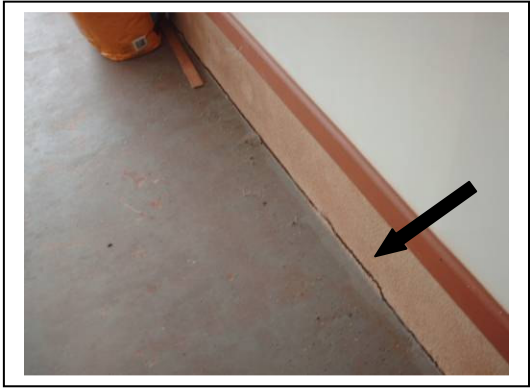
Garage floor settled somewhat

- **Safety Issue:** Although the garage door opener laser reverse did function properly, the door did not automatically reverse under resistance to closing. *There is a serious risk of injury, particularly to children, under this condition.* Improvement may be as simple as adjusting the sensitivity control on the opener. This should be dealt with immediately.
- **Monitor:** The garage floor has settled somewhat. Improvement is not considered a priority.

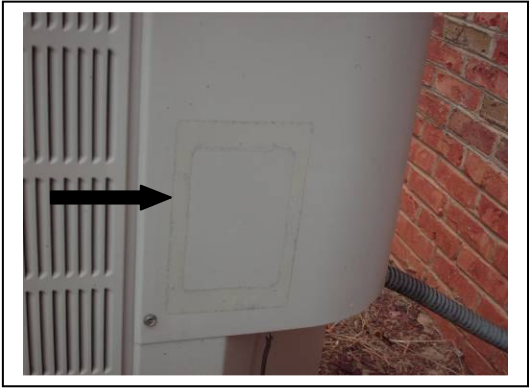
Data plate missing from the air conditioner

**System Description:** •Manufacturer Date: **Unknown-Data Plate Missing**  
 •Approximate Age (in years): **Unknown-Data Plate Missing**  
 •Model # **Unknown-Data Plate Missing**  
 •Serial # **Unknown-Data Plate Missing**  
**Temperature Drop Recorded:** 17 Degrees F
